FIRE SAFETY FOLLOW UP INSPECTION

Factory Name	Chittagong Fashion Specialized Textile Ltd.		Accord ID	11715
Address	Plot# 26, Sector # 01, road # 04, C.E.P.Z.			
Initial Inspection Date	23-Jun-2014		Report Received Date	30-Jun-2014
Date of 1st Follow-up	25-Aug-2015	Date of 2nd Follow-up	16-Mar-2016	
Date of 3rd Follow-up	17-Aug-2016	Date of 4th Follow-up	07-Nov-2016	
Date of 5th Follow-up	12-Feb-2017	Date of 6th Follow-up	04-Jul-2017	
Date of 7th Follow-up	17-Oct-2017	Date of 8th Follow-up	12-Mar-2018	
Date of 9th Follow-up	09-Sep-2018	Date of 10th Follow-up	19-Jun-2019	
Date of 11th Follow-up	28-Oct-2019	Date of 12th Follow-up		
Date of 13th Follow-up		Date of 14th Follow-up		
Inspected by	Md. Ferdaus Jaman

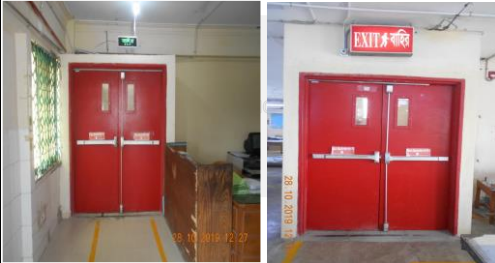
Item No	Accord Observation	Accord Recommendation	Timeline given by Accord	Comments after Physical Inspection	Supposed to complete(DD/MM/YYYY)	Final Action Plan (Factory)	Status on the date of Inspection	Pictorial Evidence
1	Fire Rated Construction: The exit stairs are not separated from work areas and other spaces on each floor by fire rated construction.	Provide minimum 1.5 hr fire rated doors and seal all unprotected openings to separate the exit stairs from work areas and other building spaces on all floor levels. Ensure that the fire doors are self closing and positive latching and that they are provided with fire exit (panic) hardware where serving production floors. If fire doors are required to be held open for functional reasons, provide automatic closing devices tied to the fire alarm system.	Within 3 Month	<p>On 16/03/2016: Fire rated doors are laid on their yard, installation work is going on & it will be completed within committed timeline.</p> <p>On 17/08/2016: Factory has installed fire doors on some stairs but installation has not completed. Certification of door closer and lock and latch has not been found. Smoke seal, door hold open device and door coordinator has not been found during follow up inspection.</p> <p>On 07/11/2016: It was same as it was previous visit.</p> <p>On 12/02/2017: Missing smoke seal, door co-ordinator & magnetic holder for interfacing fire alarm system's factory management said that it will be completed within 15 March 2017.</p> <p>On 04/07/2017: Smoke seal, door co-ordinator & magnetic holder are in house.</p> <p>On 17/10/2017: Fire door installation is completed and smoke seal, coordinator and EM door holder installation work is going on.</p> <p>On 12/03/2018: Fire door installation is completed and smoke seal, coordinator and EM door holder installation work is not completed yet.</p> <p>On 09/09/2018: It was found same as previous follow-up.</p> <p>On 19/06/2019: Corrected based on site observations.</p> <p>On 28/10/2019: Corrected.</p>	16-Apr-2016	Completed	Corrected

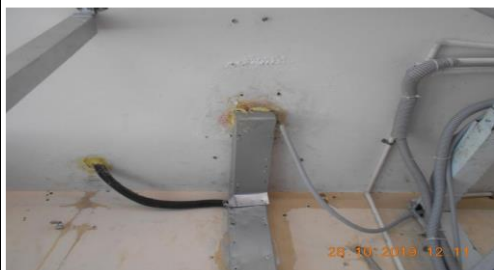
2	Fire Rated Construction: Unsealed penetrations and openings are located in the fire rated floor and ceiling assemblies.	Provide a minimum 2 hr fire rated shaft to separate the utility risers from each floor level.	Within 3 Month	<p>On 16/03/2016: Partially corrected. The factory has started to seal penetration & openings & remaining works will be completed as per standard within committed timeline.</p> <p>On 17/08/2016: Unsealed penetrations have been found during follow up inspection.</p> <p>On 07/11/2016: It was same as it was previous visit.</p> <p>On 12/02/2017: The factory management shall have to seal it properly.</p> <p>On 04/07/2017: It was same as it was previous visit.</p> <p>On 17/10/2017: Sealing work is going on.</p> <p>On 12/03/2018: Floor to floor sealing work is not completed yet.</p> <p>On 09/09/2018: It was found same as previous follow-up.</p> <p>On 19/06/2019: Corrected based on site observations.</p> <p>On 28/10/2019: Corrected.</p>	16-Apr-2016	Completed	Corrected

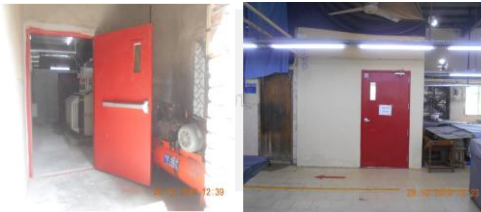
Item No	Accord Observation	Accord Recommendation	Timeline given by Accord	Comments after Physical Inspection	Supposed to complete(DD/MM/YYYY)	Final Action Plan (Factory)	Status on the date of Inspection	Pictorial Evidence
3	Fire Rated Construction: The boiler, generator, transformer and EMR room is not separated by fire rated construction due to openings, non rated doors and penetrations on the ground, fourth sixth and seventh floor.	Separate the boiler, generator transformer and EMR room by a minimum 2 hr fire rated construction. Seal and protect all openings to maintain the required fire separations.	Within 3 Month	<p>On 16/03/2016: The factory management has started civil construction works & also confirms that transformer room will be relocated new construction area.</p> <p>On 17/08/2016: Partially corrected. Factory has sealed some openings and penetrations but some openings and penetrations have not sealed properly.</p> <p>On 07/11/2016: Till penetrations & openings was found generator & Boiler room on ground floor.</p> <p>On 12/02/2017: The factory management shall have to separate generator & boiler room properly. If fire doors are required to be held open for functional reasons, provide automatic closing devices tied to the fire alarm system for 4th floor boiler room.</p> <p>On 04/07/2017: The factory shall have to seal boiler room properly.</p> <p>On 17/10/2017: New penetration has been found in the boiler room.</p> <p>On 12/03/2018: Boiler room separation work is not completed.</p> <p>On 09/09/2018: Separation work is not completed yet.</p> <p>On 19/06/2019: Corrected based on site observations.</p> <p>On 28/10/2019: Corrected.</p>	16-Apr-2016	Completed	Corrected

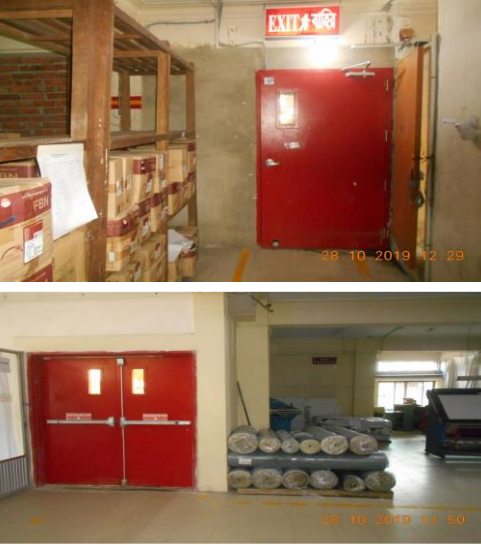
4	Fire Rated Construction: Store rooms used for combustible storages are not separated by fire rated construction on ground, third, fifth and seventh floor.	Provide dedicated storage rooms separated by minimum 1 hr fire rated construction.	Within 3 Month	<p>On 16/03/2016: The factory management has completed civil related construction works. Fire rated doors are laid on their yard, installation work is going on & it will be completed within committed timeline.</p> <p>On 17/08/2016: Factory has installed fire doors on some stores but installation has not completed. Certification of door closer and lock and latch has not been found. Smoke seal, door hold open device and door coordinator has not been found during follow up inspection.</p> <p>On 07/11/2016: It was same as it was previous visit.</p> <p>On 12/02/2017: Missing smoke seal, door co-ordinator & magnetic holder for interfacing fire alarm system's factory management said that it will be completed within 15 March 2017.</p> <p>On 04/07/2017: Smoke seal, door co-ordinator & magnetic holder are in house.</p> <p>On 17/10/2017: Factory has separated the storage room from exit stairs but doctor's room is not separated from storage.</p> <p>On 12/03/2018: Factory has installed fire rated door to separate the store rooms but door coordinator is non-functional and EM door holder is not interface with FACP. Also doctor's room is not removed/separated from store room on ground floor.</p> <p>On 09/09/2018: It was found same as previous follow-up.</p> <p>On 19/06/2019: Corrected based on site observations.</p> <p>On 28/10/2019: Corrected.</p>	16-Apr-2016	Completed	Corrected

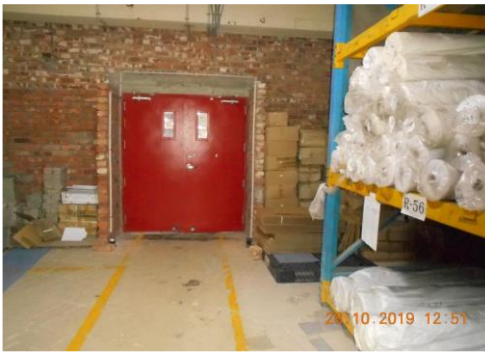
Item No	Accord Observation	Accord Recommendation	Timeline given by Accord	Comments after Physical Inspection	Supposed to complete(DD/MM/YYYY)	Final Action Plan (Factory)	Status on the date of Inspection	Pictorial Evidence
5	Fire Rated Construction: Areas used for combustible storages are open on ground and fourth floor.	Provide defined storage areas and limit the storage arrangement as follows: - Maximum height of 2.4m and maximum area of 23 m2 .- Separate areas of unclosed areas of storage by a minimum clear distance of 3m.	Within 3 Month	On 16/03/2016: The factory has started this process & it will be completed within committed timeline. Final CAP Timeline: Expired. Committed Timeline: Within 16 April 2016 On 17/08/2016: Storage area has been found at 4th floor and ground floor. On 07/11/2016: It was same as it was previous visit. On 12/02/2017: Corrected. Areas used(in process storage) has been found within limit during 5th follow up visit. On 04/07/2017: Corrected. On 17/10/2017: Corrected as per site observation. On 12/03/2018: Corrected. On 09/09/2018: Corrected. On 19/06/2019: Corrected. On 28/10/2019: Corrected.	16-Apr-2016	Completed	Corrected

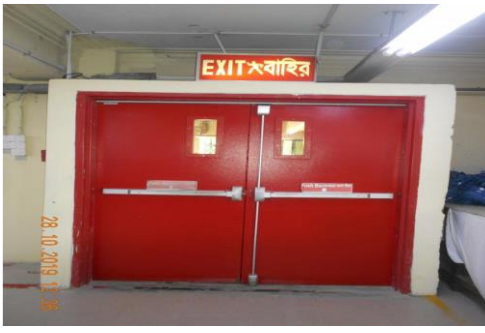
7	Egress: Egress doors and gates with locking features (padlocks) are provided at building exits, exit stairs and along egress routes. All gates and doors were not open and unlocked during the inspection.	Remove locking features from all egress doors and gates. If locks are required for security reasons, utilize special door locking features complying with NFPA 101.	Immediate	On 16/03/2016: Corrected. Not found non-complaint doors/gates having non-complaint locking features from the egress routes during 2nd follow up visit. On 17/08/2016: Corrected. Locking features have not been found during follow up inspection. On 07/11/2016: Corrected. On 12/02/2017: Corrected. On 04/07/2017: Corrected. On 17/10/2017: Corrected. On 12/03/2018: Corrected. On 09/09/2018: Corrected. On 19/06/2019: Corrected. On 28/10/2019: Corrected.	25-Aug-2015	Completed	Corrected

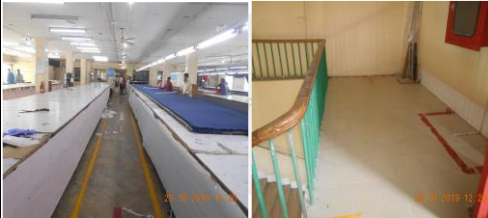
Item No	Accord Observation	Accord Recommendation	Timeline given by Accord	Comments after Physical Inspection	Supposed to complete(DD/MM/YYYY)	Final Action Plan (Factory)	Status on the date of Inspection	Pictorial Evidence
8	Egress: Storage is located in the egress path on all the floors except sixth and seventh floors	Keep egress paths and stairs clear of storage.	Immediate	On 16/03/2016: Partially corrected. The factory management shall be kept clear of egress routes within committed timeline. On 17/08/2016: Partially corrected. Electrical DB has been found on the egress path on some floors. On 07/11/2016: Storage was found on aisles for several floors during 4th follow up visit. On 12/02/2017: Corrected. Storage was not found on aisles during 5th follow up visit. On 04/07/2017: Corrected. On 17/10/2017: Corrected. On 12/03/2018: Corrected. On 09/09/2018: Corrected. On 19/06/2019: Corrected. On 28/10/2019: Corrected.	20-Mar-2016	Completed	Corrected

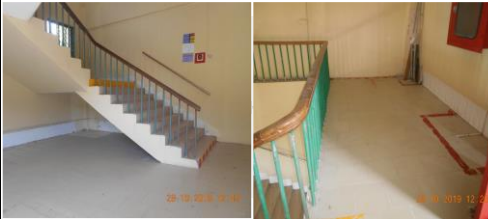
9	Egress: Storage is located in all the exits stairs on all the floors.	Remove all storage from exit stairs and egress paths	Immediate	On 16/03/2016: Corrected. On 17/08/2016: Corrected. On 07/11/2016: Corrected. On 12/02/2017: Corrected. On 04/07/2017: Corrected. On 17/10/2017: Corrected. On 12/03/2018: Corrected. On 09/09/2018: Corrected. On 19/06/2019: Corrected. On 28/10/2019: Corrected.	25-Aug-2015	Completed	Corrected

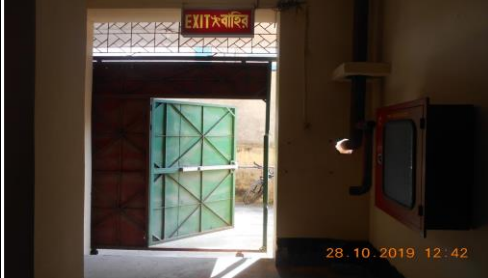
10	Egress: Collapsible gates and sliding doors are provided at building exits, exit stairs, along egress routes and exit discharge.	Replace all gates and sliding doors the means of egress with side hinged, swinging egress doors. If locks are required for security reasons, utilize special door locking features complying with NFPA 101.	Within 1 month.	On 16/03/2016: Corrected. Not found non-complaint doors/gates from the egress routes during 2nd follow up visit. On 17/08/2016: Corrected. Non compliant gates have not found during follow up inspection. On 07/11/2016: Corrected. On 12/02/2017: Corrected. On 04/07/2017: Corrected. On 17/10/2017: Corrected. On 12/03/2018: Corrected. On 09/09/2018: Corrected. On 19/06/2019: Corrected. On 28/10/2019: Corrected.	25-Aug-2015	Completed	Corrected

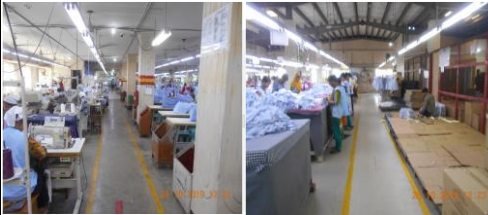
Item No	Accord Observation	Accord Recommendation	Timeline given by Accord	Comments after Physical Inspection	Supposed to complete(DD/MM/YYYY)	Final Action Plan (Factory)	Status on the date of Inspection	Pictorial Evidence
11	Fire Protection: The width of egress aisles is less than 36 in on all the floors except sixth and seventh floors.	Provide minimum aisles widths of 36- in.	Within 3 months	<p>On 16/03/2016: Partially corrected. The factory management has started to increase aisles width & remaining works will be completed within committed timeline.</p> <p>On 17/08/2016: Partially corrected. Aisle is less than 36 inch has been found at cutting section on 4th floor and finishing section on 1st floor.</p> <p>On 07/11/2016: The factory shall have to provide aisles mark minimum width 36 in where is required.</p> <p>On 12/02/2017: It was same as it was previous visit for 5th & 4th floors.</p> <p>On 04/07/2017: It was same as it was previous visit for 5th floor.</p> <p>On 17/10/2017: In progress. Factory is marking to provide 36 inch aisles.</p> <p>On 12/03/2018: Less than 36 inch width of aisles has been found during follow-up inspection.</p> <p>On 09/09/2018: Work is underway.</p> <p>On 19/06/2019: Corrected based on site observations.</p> <p>On 28/10/2019: Corrected.</p>	16-Apr-2016	Completed	Corrected

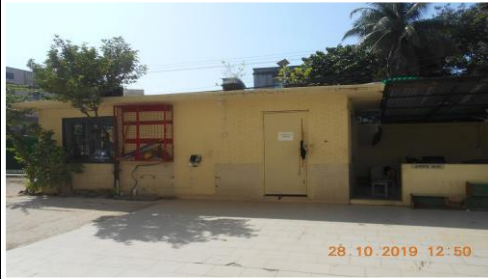
12	Fire Protection: The day care room has a travel distance more than 9m . On the ground floor.	Relocate day care room on ground floor with maximum travel distance of 9m. (30ft)	Within 3 months	<p>On 16/03/2016: Corrected. The factory management has relocated day care room for the ground floor to near main gate.</p> <p>On 17/08/2016: Corrected. Day care room has been relocated.</p> <p>On 07/11/2016: Corrected.</p> <p>On 12/02/2017: Corrected.</p> <p>On 04/07/2017: Corrected.</p> <p>On 17/10/2017: Corrected.</p> <p>On 12/03/2018: Corrected.</p> <p>On 09/09/2018: Corrected.</p> <p>On 19/06/2019: Corrected.</p> <p>On 28/10/2019: Corrected.</p>	25-Aug-2015	Completed	Corrected

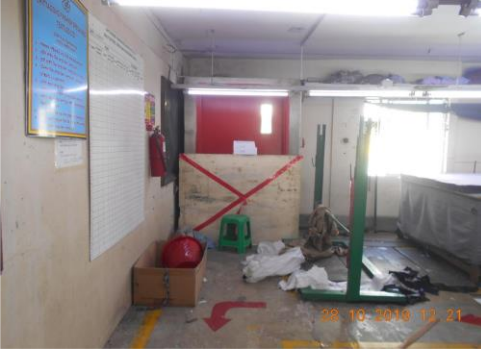
Item No	Accord Observation	Accord Recommendation	Timeline given by Accord	Comments after Physical Inspection	Supposed to complete(DD/MM/YYYY)	Final Action Plan (Factory)	Status on the date of Inspection	Pictorial Evidence
14	Egress: West exit stairs discharge inside the building on the ground and fourth floors and discharge through production and storage areas.	Provide 2 hr fire rated exit passageway leading directly outside (vestibules to separate any storage areas).	Within 6 months	<p>On 16/03/2016: The factory has completed civil construction works for ground floor & fire door installation work is going on but no action has been taken yet for 3rd floor.</p> <p>On 17/08/2016: Interior discharge has been found from 6th floor to 4th floor.</p> <p>On 07/11/2016: It was same as it was previous visit.</p> <p>On 12/02/2017: It was same as it was previous visit.</p> <p>On 04/07/2017: It was same as it was previous visit.</p> <p>On 17/10/2017: Partially corrected.</p> <p>On 12/03/2018: Interior discharge has been found from 6th floor to 4th floor.</p> <p>On 09/09/2018: It was found same as previous follow-up.</p> <p>On 19/06/2019: Work is underway.</p> <p>On 28/10/2019: Corrected.</p>	21-Apr-2016	New stair will be constructed inside of the building. Proposed drawing & load calculation will be provided to Accord Structural Team by 10/10/2019. After getting approval from Accord Structural Team it'll be completed by 15/11/2019	Corrected

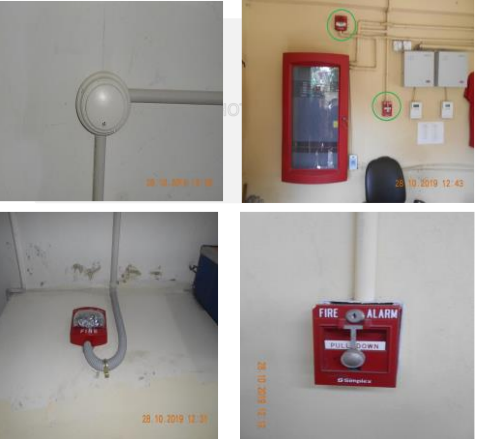
15	Fire Protection: The fire alarm system is antiquated, not a listed system, and does not provide alarm and notification features consistent with acceptable standards.	Replace the fire alarm system with a new, listed addressable fire alarm system in accordance with NFPA 72.	Design 4 months, install 9 months	<p>On 17/08/2016: Accord reviewed design has been found during follow up inspection and as per factory information factory is going to open L/C for fire alarm system with in few days.</p> <p>On 07/11/2016: The factory has opened L/C for automatic fire alarm equipment's & also ensures that it will be installed within 15/12 /2016.</p> <p>On 12/02/2017: Installation work is going on & the factory said that it will be completed within 28 February 2017. All stuff should have third-party certified mark/level & this documents require submission to Accord for verification.</p> <p>On 04/07/2017: Installation work is almost completed. Only remain for connection & testing-commissioning.</p> <p>On 17/10/2017: Installation work is almost completed except interfacing of fire doors and exhaust fans.</p> <p>On 12/03/2018: Factory has remove some detectors from the production floors and no progress since last follow-up.</p> <p>On 09/09/2018: Installation of fire alarm system is not completed and no progress since last follow-up.</p> <p>On 19/06/2019: Installation is completed & waiting for T&C from contractor side. After complete this work, the factory shall have to submit all necessary documents to Accord for Pre-T&C VI.</p> <p>On 28/10/2019: Installation of fire alarm system is completed and factory is waiting for T&C from contractor side.</p>	15-Jun-2016	CFDS installed & operational. Waiting to receive testing & commissioning report from third party. After getting the report we'll request Accord to do the T&C by 30/10/2019	In Progress

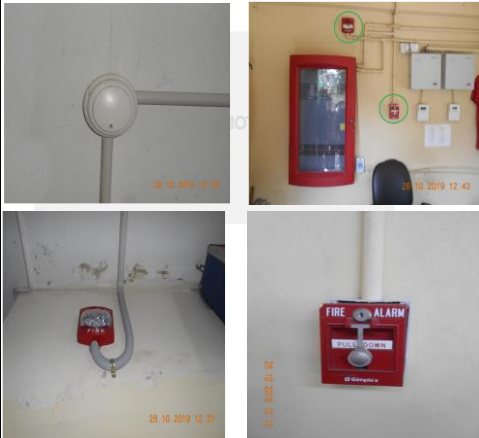
Item No	Accord Observation	Accord Recommendation	Timeline given by Accord	Comments after Physical Inspection	Supposed to complete(DD/MM/YYYY)	Final Action Plan (Factory)	Status on the date of Inspection	Pictorial Evidence
16	Fire Protection: Inspection, testing, and maintenance for the fire alarm system are not in accordance with NFPA 72.	Inspect, test and maintain the fire alarm system, and keep written records on site, in accordance with NFPA 72.	Within 3 month	<p>On 16/03/2016: The factory management is keeping written records on-site & it will be completed accordance with NFPA 72 after installation of new system.</p> <p>On 17/08/2016: Partially corrected. Factory is maintaining the checklist for the existing system but the installed existing system is not as per NFPA 72.</p> <p>On 07/11/2016: It was same as it was previous visit.</p> <p>On 12/02/2017: The factory management said that it will be completed after installation of new system.</p> <p>On 04/07/2017: It was same as it was previous visit.</p> <p>On 17/10/2017: Installation is almost completed and it will be completed after T&C.</p> <p>On 12/03/2018: It will be completed after T&C.</p> <p>On 09/09/2018: Installation of fire alarm system is not completed and no progress since last follow-up.</p> <p>On 19/06/2019: Installation is completed & waiting for T&C from contractor side. After complete this work, the factory shall have to submit all necessary documents to Accord for Pre-T&C VI.</p> <p>On 28/10/2019: Installation of fire alarm system is completed and factory is waiting for T&C from contractor side.</p>	17-Apr-2016	CFDS installed & operational. Waiting to receive testing & commissioning report from third party. After getting the report we'll request Accord to do the T&C by 30/10/2019	In Progress

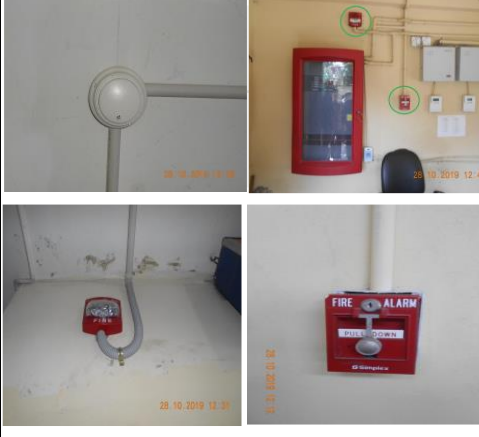
17	Fire Protection: The building is equipped with single station smoke alarms. Smoke alarm activation sounds only a local alarm and does not provide automatic fire alarm notification of occupants.	Remove single station smoke alarms. Provide automatic smoke detection throughout the building in accordance with NFPA 72.	Within 6 month	<p>On 16/03/2016: It is an integrated part of automatic fire alarm system.</p> <p>On 21/07/16: Not corrected yet. Factory asking timeline 30/09/16 is not acceptable. Factory has to complete this issue with no more delay.</p> <p>On 17/08/2016: It is an integrated part of fire alarm system.</p> <p>On 07/11/2016: It is an integrated part of fire alarm system.</p> <p>On 12/02/2017: Installation work is in progress.</p> <p>On 04/07/2017: It is an integrated part of fire alarm system.</p> <p>On 17/10/2017: Installation work is almost completed except interfacing of fire doors and exhaust fans.</p> <p>On 12/03/2018: Factory has remove some detectors from the production floors and no progress since last follow-up.</p> <p>On 09/09/2018: It was found same as previous follow-up.</p> <p>On 09/09/2018: Installation of fire alarm system is not completed and no progress since last follow-up.</p> <p>On 19/06/2019: Installation is completed & waiting for T&C from contractor side. After complete this work, the factory shall have to submit all necessary documents to Accord for Pre-T&C VI.</p> <p>On 28/10/2019: Installation of fire alarm system is completed and factory is waiting for T&C from contractor side.</p>	15-Jun-2016	CFDS installed & operational. Waiting to receive testing & commissioning report from third party. After getting the report we'll request Accord to do the T&C by 30/10/2019	In Progress

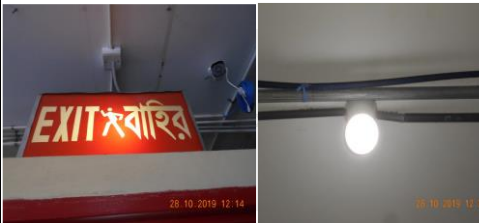
18	Egress Lighting: Emergency lighting did not function in test mode on the second floor.	Regularly test the emergency lighting system on each floor and replace and repair emergency lighting system including the alternative instant power supply as needed.	Within 1 month.	<p>On 16/03/2016: Corrected.</p> <p>On 17/08/2016: Corrected.</p> <p>On 07/11/2016: Corrected.</p> <p>On 12/02/2017: Corrected.</p> <p>On 04/07/2017: Corrected.</p> <p>On 17/10/2017: Corrected.</p> <p>On 12/03/2018: Corrected.</p> <p>On 09/09/2018: Corrected.</p> <p>On 19/06/2019: Corrected.</p> <p>On 28/10/2019: Corrected.</p>	25-Aug-2015	Completed	Corrected

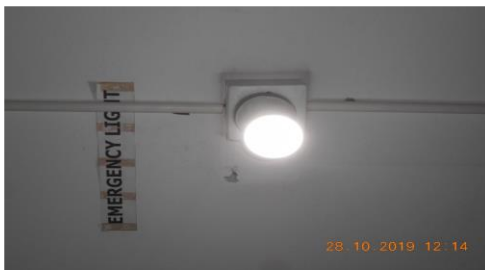
Item No	Accord Observation	Accord Recommendation	Timeline given by Accord	Comments after Physical Inspection	Supposed to complete(DD/MM/YYYY)	Final Action Plan (Factory)	Status on the date of Inspection	Pictorial Evidence
19	Egress Lighting: Manual on off switch is provided for emergency lighting and exit signage units in the west exit stair.	Remove manual on/off switches from emergency lighting and exit signage units to prevent them from being switched off.	Within 1 month	On 16/03/2016: Corrected. On 17/08/2016: Corrected. Manual on-off switch has not been found during follow up inspection. On 07/11/2016: Corrected. On 12/02/2017: Corrected. On 04/07/2017: Corrected. On 17/10/2017: Corrected. On 12/03/2018: Corrected. On 09/09/2018: Corrected. On 19/06/2019: Corrected. On 28/10/2019: Corrected.	25-Aug-2015	Completed	Corrected

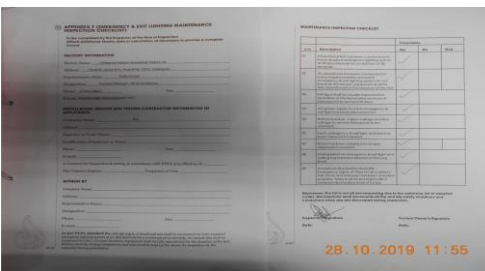
20	Egress Lighting: Inspection, testing and maintenance for the emergency lighting system are not in accordance with the accord standard.	Inspect, test and maintain the emergency lighting system in accordance with the ACCORD standard.Keep written records on site.	Within 3 months	On 16/03/2016: Corrected. The factory management is keeping written records on-site & it will be also developed as per Accord standard. On 17/08/2016: Corrected. Factory is maintaining the checklist. On 07/11/2016: Corrected. On 12/02/2017: Corrected. On 04/07/2017: Corrected. On 17/10/2017: Corrected. On 12/03/2018: Corrected. On 09/09/2018: Corrected. On 19/06/2019: Corrected. On 28/10/2019: Corrected.	05-Oct-2015	Completed	Corrected

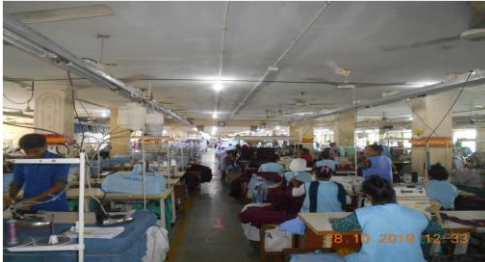
21	Egress Lighting: Based on the number and location of emergency lights observed, adequate illumination levels are not anticipated along egress routes on the factory floors and exit stairs.	Test the emergency lighting system on each floor and provide additional emergency fixtures to provide adequate illumination along the means of egress. Provide a minimum illumination of 10 lux at the floor level within exit stairs and minimum 2.5 lux along exit access aisles.	Within 3 months	On 16/03/2016: Partially corrected. The factory management shall have to provide additional exit light (10 lux) & directional sign where is required as per standard. On 17/08/2016: Partially corrected. Factory has installed some emergency light but need to installed more light. It is required to install directional light at several floors. On 07/11/2016: The factory shall have to provide emergency light (10 lux) on exit door & directional sign where is required as per standard. On 12/02/2017: Corrected. On 04/07/2017: Corrected. On 17/10/2017: Corrected. On 12/03/2018: Corrected. On 09/09/2018: Corrected. On 19/06/2019: Corrected. On 28/10/2019: Corrected.	30-Mar-2016	Completed	Corrected

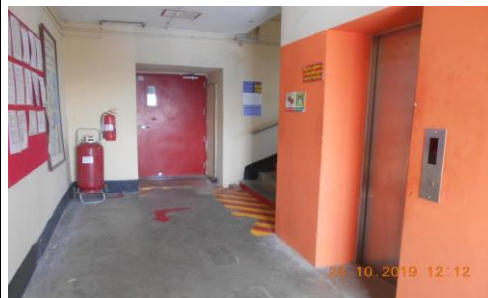
23	New Findings(1st follow up): For lift shaft unsealed penetrations and openings are located in the fire rated floor ceiling assemblies throughout the building.	Provide a minimum 2-hr fire rated shaft to separate the utility riser from each floor level. Seal all penetrations and openings in floor/ceiling assemblies to maintain the required fire separations.	Within 1 month	<p>On 16/03/2016: Corrected.</p> <p>On 17/08/2016: Corrected. It is required to separate the lift at the 6th floor from dining area. If fire doors are required to be held open for functional reasons then fire door is required to interface with the fire alarm system.</p> <p>On 07/11/2016: Corrected.</p> <p>On 12/02/2017: Corrected.</p> <p>On 04/07/2017: Corrected.</p> <p>On 17/10/2017: Corrected.</p> <p>On 12/03/2018: Corrected.</p> <p>On 09/09/2018: Corrected.</p> <p>On 19/06/2019: Corrected.</p> <p>On 28/10/2019: Corrected.</p>	25-Sep-2015	Completed	Corrected

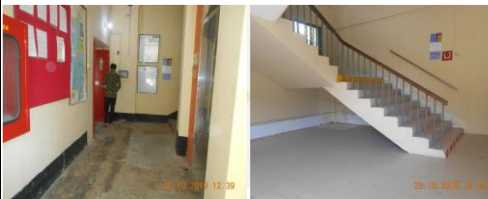
24	New Finding(1st follow up): Storage is located in the west-north exit stair enclosure (compressor) and east-south exit stair enclosure (spot removing room) on ground floor.	Remove all storage from exit stairs enclosure and egress paths. Or Separate the compressor and spot removing room by a minimum 2-hr fire-rated construction. Seal and/or protected all openings to maintain the required fire separations.	Within 3 months	<p>On 16/03/2016: The factory management confirms that it will be completed within committed timeline.</p> <p>Final CAP Timeline: Expired.</p> <p>Committed Timeline: Within 16 April 2016</p> <p>On 17/08/2016: Partially corrected. Compressor and spot removing room has not been found at exit stair but IPS system has been found underneath of north-west exit stair.</p> <p>On 07/11/2016: Corrected.</p> <p>On 12/02/2017: Corrected.</p> <p>On 04/07/2017: Corrected.</p> <p>On 17/10/2017: Corrected.</p> <p>On 12/03/2018: Corrected.</p> <p>On 09/09/2018: Corrected.</p> <p>On 19/06/2019: Corrected.</p>	16-Apr-2016	Completed	Corrected

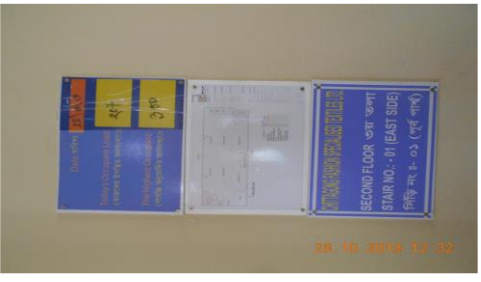
Item No	Accord Observation	Accord Recommendation	Timeline given by Accord	Comments after Physical Inspection	Supposed to complete(DD/MM/YYYY)	Final Action Plan (Factory)	Status on the date of Inspection	Pictorial Evidence
25	New Finding (2nd follow up-16-03-2016): Building did not have stair designation & occupant load signs at the factory floors.	Provide stair designation signs & occupant load signs at required locations in Bengali & English.	Immediate	On 16/03/2016: New finding (2nd follow up). On 17/08/2016: Corrected. Stair designation signs and occupant load signs have been provided. On 07/11/2016: Corrected. On 12/02/2017: Corrected. On 04/07/2017: Corrected. On 17/10/2017: Corrected. On 12/03/2018: Corrected. On 09/09/2018: Corrected. On 19/06/2019: Corrected. On 28/10/2019: Corrected.	30-Mar-2016	Completed	Corrected

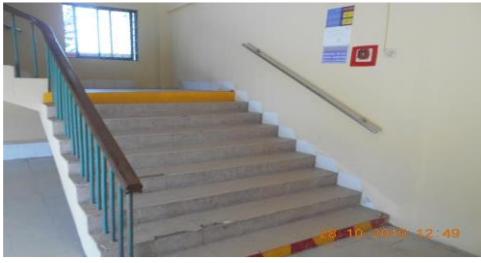
26	New Finding (2nd follow up-16-03-2016): Handrails are provided on single side of stairways of the main factory building.	Provide handrails on both sides of each stairway and a mounting height of the handrail should be within the range of 865 mm (34 in.) and 965 mm (38 in.).	Within 1 month	On 16/03/2016: New finding (2nd follow up). On 17/08/2016: Corrected. Both side hand rail has been provided. On 07/11/2016: Corrected. On 12/02/2017: Corrected. On 04/07/2017: Corrected. On 17/10/2017: Corrected. On 12/03/2018: Corrected. On 09/09/2018: Corrected. On 19/06/2019: Corrected. On 28/10/2019: Corrected.	16-Apr-2016	Completed	Corrected

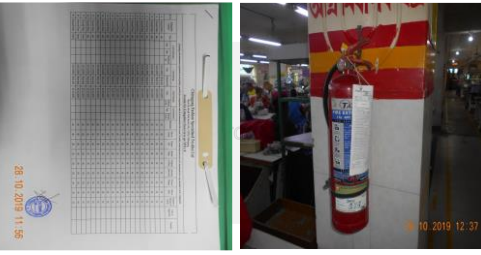
27	New Finding (3rd follow up): Inspection, testing and maintenance of portable fire extinguishers is not in accordance with NFPA 10.	Inspect, test and maintain the portable fire extinguishers and keep written records on-site, in accordance with NFPA 10.	within 02 weeks	On 17/08/2016: New Finding (3rd follow up). On 07/11/2016: Corrected. The factory should update it accordance with NFPA 10 chapter 7. On 12/02/2017: Corrected. On 04/07/2017: Corrected. On 17/10/2017: Corrected. On 12/03/2018: Corrected. On 09/09/2018: Corrected. On 19/06/2019: Corrected. On 28/10/2019: Corrected.	30-Aug-2016	Completed	Corrected
