Structural Safety Inspection

Factory Name	Chittagong Fashion Specialized Textile Ltd.	Accord ID	11715
Factory Address	Plot# 26, Sector # 01, road # 04, C.E.P.Z.		
Inspection Date	11-Feb-2014		
Date of Review Inspection	15-Oct-19		
Inspected by	Md. Moin Uddin

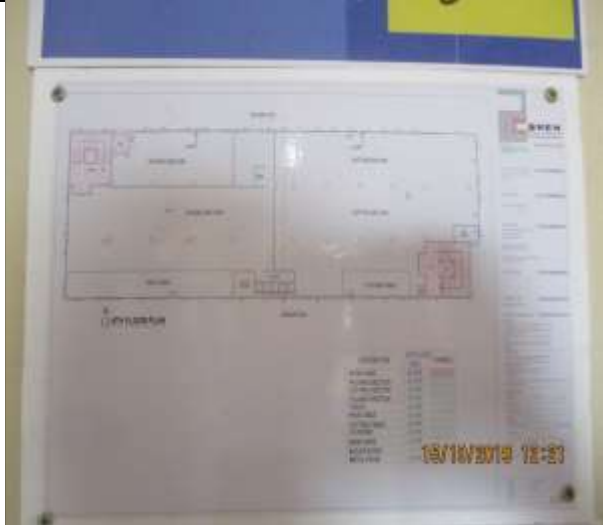
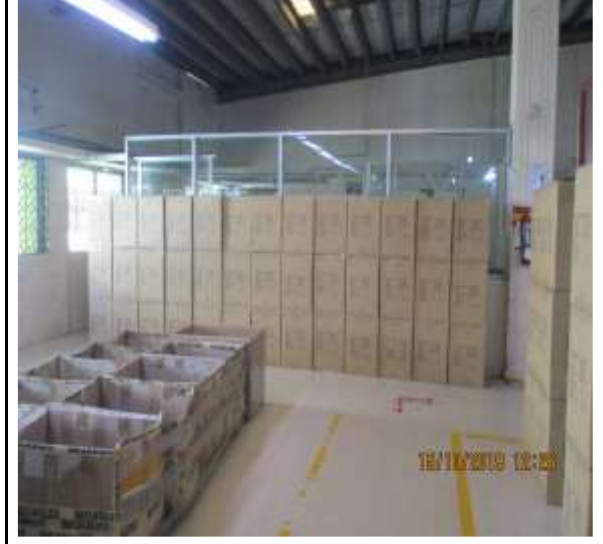
3	Verify the structural adequacy of building columns at all levels based on as built dimensions and material properties.	Priority-3-Produce and actively manage a loading plan for all floor plates within the factory giving consideration to floor capacity and column capacity.	Priority-3 (Within 6 months)	Completed	19-Mar-2016	<p>On 11/03/2016: Previous Timeline: 30/12/2015, Final Timeline: 19/03/2016 Load plan found posted but no implementation was seen. Uncontrolled high loading was seen on 4th floor fabric roll storage & 3rd floor accessories store. Factory management committed to reduce load within 19/03/2016.</p> <p>On 12/02/2017: No load management plan was seen. Loading was seen uncontrolled. The load plan found was not satisfactory. It is required that the load plan should be maintained strictly .</p> <p>On 13/8/2017: Load management was not seen during inspection. Overloading and uncontrolled loading was seen on several floors. As per the accepted Safe load plan factory has to follow 20 psf on all floors. But it was not followed at all. A canteen and dining area was found on 6th floor in which the load exceeds far more than safe load plan. Factory has to follow the safe load plan strictly and install the immediate propping for the required columns.</p> <p>On 17/10/2017: Load management was not seen during inspection. As per the accepted Safe load plan factory has to follow 20 psf on all floors. A canteen and dining area was found on 6th floor in which the load exceeds far more than safe load plan. Factory has to follow the safe load plan strictly and install the immediate propping for the required columns.</p> <p>On 21/02/2018: Load plan has been produced as part of EA. Factory performed EA and EA was accepted by ACCORD on 12/11/2017. Factory didn't post any load plan. Factory is required to post safe load plan until retrofitting completed. Final load plan will be posted after completion of retrofitting works. Loading was found within 20psf as per accepted EA. During verification inspection, some discrepancies were found. Factory is required to submit revised EA as per verification report within given timeline in report.</p> <p>On 09/09/2018: Load plan has been prepared along with EA report which was approved by ACCORD on 12-11-2017. Loading was found within 20 psf as per accepted EA, but factory didn't post any load plan. After the verification inspection factory submitted the revised EA to ACCORD on 28/06/2018 which is under review.</p> <p>On 24/11/2018: Load plan has been prepared which was accepted by ACCORD. During inspection, loading was observed within the allowable load limit (42 psf) as per accepted load plan. Factory will post final load plan after completion of remedial works.</p> <p>On 12/05/2019: Load plan has been produced and got acceptance from ACCORD. During inspection loading was found within allowable safe limit (20 psf), Load plan was found posted in every floor. Remediation work has not completed till the inspection date. Factory will post final load plan after completion of remedial works.</p> <p>On 15/10/2019: Load plan has been prepared which was accepted by ACCORD. During inspection, loading was found within the allowable load limit (42 psf) and load plan was found posted on each floor.</p>	Corrected

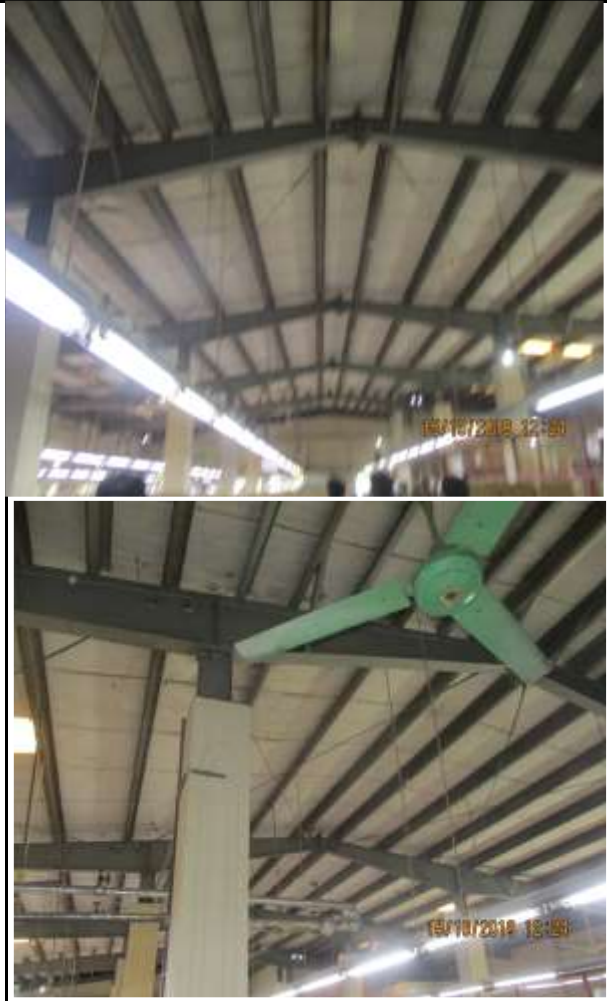
10	Lightweight steel roof to the east block does not appear to be adequately braced to resist high wind loading.	Priority -2-Steel roof to the east block should be designed by the building engineer including the provision of a lateral stability system and, if required, upgraded to support code vertical and wind loads or the area should be vacated and removed.	Priority-2 (Within 6 weeks)	Completed	18-Apr-2016	<p>On 16/03/2016: Previous Timeline: 11/02/2016 Committed Timeline: 24/03/2016 An engineering assessment was submitted last on 23/12/2014 and after that still its revised submission is pending. Factory management & their consultant committed to submit their EA report within 24/03/2016. so this issue will be covered in EA report.</p> <p>On 12/02/2017: This issue was covered in EA. EA was not accepted from Accord yet.</p> <p>On 13/8/2017:This issue is required to be covered under EA. The EA of the factory has been submitted to Accord which is under review.</p> <p>On 17/10/2017: This issue is required to be covered under EA. The EA of the factory has been submitted to Accord which is under review.</p> <p>On 21/03/2018: This issue has been covered in EA. Factory performed EA and EA was accepted by ACCORD on 12/11/2017. Factory will follow remedial works as per recommendation of accepted EA.</p> <p>On 09/09/2018: This issue is required to cover in Engineering Assessment (EA). Factory performed EA and EA was accepted by ACCORD on 12/11/2017. After the verification inspection factory submitted the revised EA to ACCORD on 28/06/2018 which is under review.</p> <p>On 24/11/2018: Factory has prepared DEA and got acceptance from ACCORD on 12-11-2017. After the verification inspection factory submitted revised DEA documents to ACCORD and got re-acceptance on 21-11-2018. Factory required to complete all remedial works within 15-Feb-2019. The remediation work was not started till the inspection day.</p> <p>On 12/05/2019: Factory prepared DEA and got acceptance from ACCORD on 21-11-2018. As per the approved retrofitting recommendation, factory has almost completed 80% remediation work. As per approval, remediation completion timeline was 15-02-2019.</p> <p>On 15/10/2019: This issue has been covered in Detailed Engineering Assessment (DEA). Factory has carried out DEA and got acceptance from ACCORD. As per approved DEA, factory has completed all remediation works.</p>	Corrected

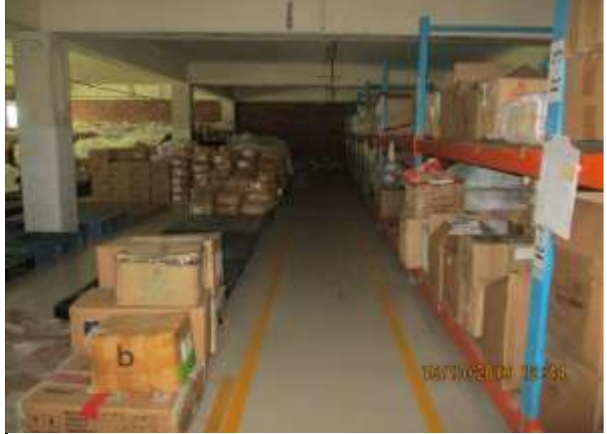
14	Management of storage load in the east and west blocks.	Walkways to be provided within all storage areas.	Priority-2 (Within 6 weeks)	Corrected	07-Oct-2015	<p>On 16/03/2016: Previous Timeline: 10/07/2015 This issue found corrected during 1st follow up. During inspection we also observed walkways were found to be provided. Although uncontrolled loading was observed on different floors of the factory.</p> <p>On 12.02.2017: Corrected in previous follow up.</p> <p>On 13/8/2017: Corrected in previous follow up.</p> <p>On 17/10/2017: Corrected in previous follow up.</p> <p>On 21/03/2018: This issue was corrected from previous inspection.</p> <p>On 09/09/2018: This issue has been corrected from previous inspection.</p> <p>On 24/11/2018: Corrected from previous follow up. During inspection, walkways found in storage areas.</p> <p>On 12/05/2019: The issue is corrected as per previous inspection.</p> <p>On 15/10/2019: Corrected in previous follow up inspection.</p>	Corrected

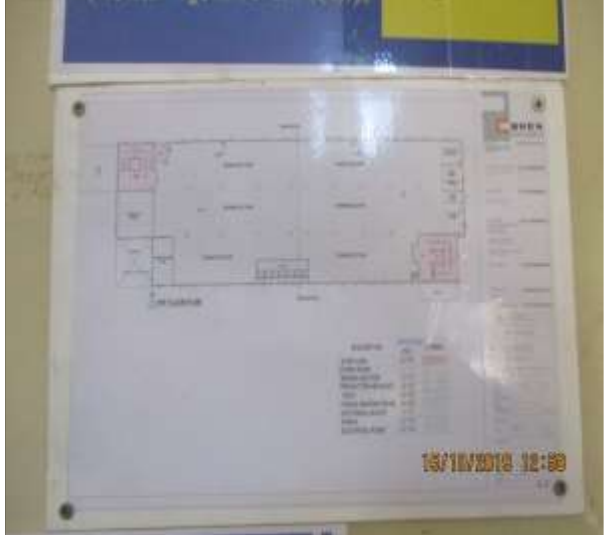
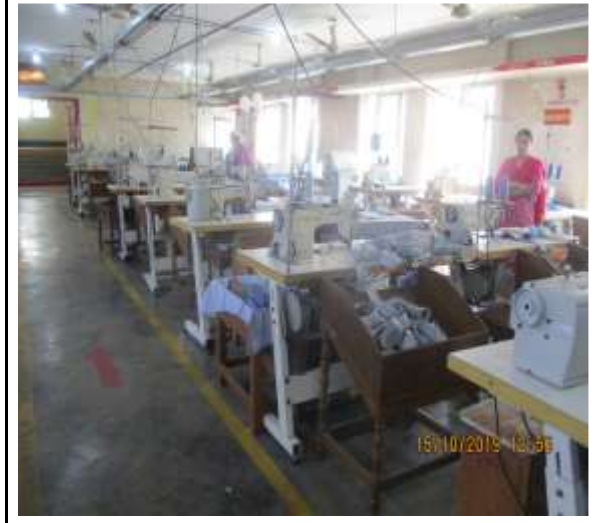
Item No	Accord Observation	Accord Recommendation	Accord Timeline	Final Action Plan	Final Timeline(DD/MM/YYYY)	Comments after Physical Inspection	Progress Status	Pictorial Evidence
15	Management of storage load in the east and west blocks.	Building engineer to produce and actively manage a loading plan for all floor plates within the factory giving consideration to floor capacity and column capacity.	Priority-2 (Within 6 weeks)	Completed	19-Mar-2016	<p>On 16/03/2016: Previous Timeline: 30/12/2015 Final Timeline: 19/03/2016 Load plan found posted but no implementation was seen. Uncontrolled high loading was seen on 4th floor fabric roll storage & 3rd floor accessories store. Factory management committed to reduce load within 19/03/2016.</p> <p>On 12/02/2017: Load plan was not found sufficient. Also no load marking was observed. It is required factory implement safe load plan before retrofitting is completed. After completion of the remediation final load plan can be posted.</p> <p>On 13/8/2017: Load management was not seen during inspection. Overloading and uncontrolled loading was seen on several floors. As per the accepted Safe load plan factory has to follow 20 psf on all floors. But it was not followed at all. A canteen and dining area was found on 6th floor in which the load exceeds far more than safe load plan. Factory has to follow the safe load plan strictly and install the immediate propping for the required columns.</p> <p>On 17/10/2017: Load management was not seen during inspection. As per the accepted Safe load plan factory has to follow 20 psf on all floors. A canteen and dining area was found on 6th floor in which the load exceeds far more than safe load plan. Factory has to follow the safe load plan strictly and install the immediate propping for the required columns.</p> <p>On 21/02/2018: Load plan has been produced as part of EA. Factory performed EA and EA was accepted by ACCORD on 12/11/2017. Factory didn't post any load plan. Factory is required to post safe load plan until retrofitting completed. Final load plan will be posted after completion of retrofitting works. Factory is also required to appoint a designated load manager to ensure load management program. Loading was found within 20psf as per accepted EA. During verification inspection, some discrepancies were found. Factory is required to submit revised EA as per verification report within given timeline in report.</p> <p>On 09/09/2018: Load plan has been prepared along with EA report which was approved by ACCORD on 12-11-2017. Loading was found within 20 psf as per accepted EA, but factory didn't post any load plan. After the verification inspection factory submitted the revised EA to ACCORD on 28/06/2018 which is under review.</p> <p>On 24/11/2018: Load plan has been prepared which was accepted by ACCORD. During inspection, loading was observed within the allowable load limit (42 psf) as per accepted load plan. Factory will post final load plan after completion of remedial works.</p> <p>On 12/05/2019: Load plan has been produced and got acceptance from ACCORD. During inspection loading was found within allowable safe limit (20 psf), Load plan was found posted in every floor. Remediation work has not completed till the inspection date. Factory will post final load plan after completion of remedial works.</p> <p>On 15/10/2019: Load plan has been prepared which was accepted by ACCORD. During inspection, loading was found within the allowable load limit (42 psf) and load plan was found posted on each floor.</p>	Corrected

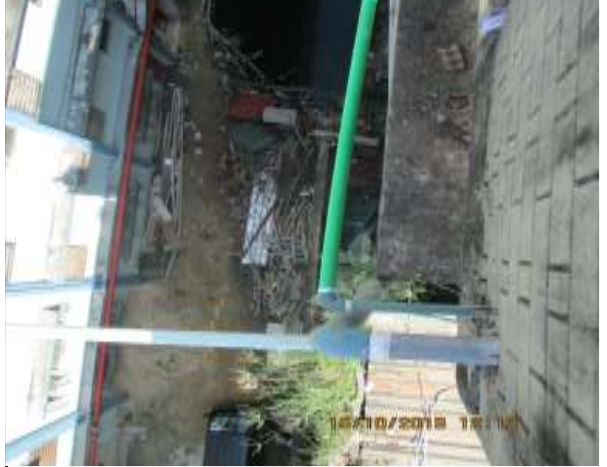
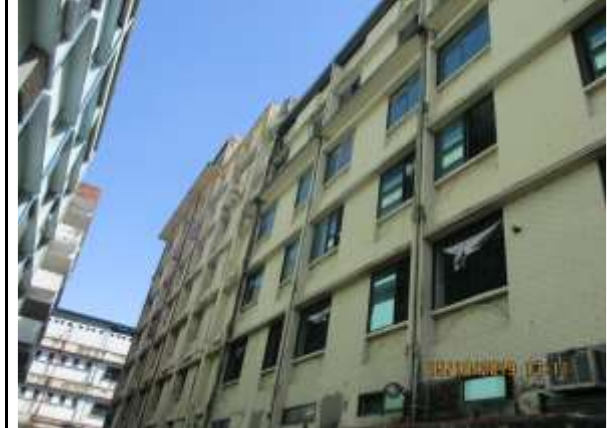
Item No	Accord Observation	Accord Recommendation	Accord Timeline	Final Action Plan	Final Timeline(DD/MM/YYYY)	Comments after Physical Inspection	Progress Status	Pictorial Evidence
16	Load capacity of external fire escape stairs.	Priority-2-Building engineer to carry out design calculations to verify the load capacity of the external escape stairs for crowd loading in the event of use in an emergency.	Priority-2 (Within 6 weeks)	The stair is now non operational. And we got the new stair drawing with details. This new stair will be constructed inside of the building. Proposed drawing & load calculation will be provided to Accord Structural Team by 10/10/2019 & new stair will be installed by 15/11/2019	24-Apr-2016	<p>On 16/03/2016: Previous Timeline: 15/03/2016 Committed Timeline: 24/03/2016 It was found the same state. Factory management & their consultant committed to submit their EA report within 24/03/2016. so this issue will be covered in EA report. It is required to follow ACCORD recommendation properly</p> <p>On 12/02/2017: This issue was covered in EA. EA was not accepted from Accord yet.</p> <p>On 13/8/2017:This issue is required to be covered under EA. The EA of the factory has been submitted to Accord which is under review. Moreover during inspection it was found that the fire escape stair was in very marginal state. The factory management has to stop using the stair immediately.</p> <p>On 17/10/2017:This issue is required to be covered under EA. The EA of the factory has been submitted to Accord which is under review. Moreover during inspection it was found that the fire escape stair was in very marginal state. The factory management has to stop using the stair immediately.</p> <p>On 21/03/2018: This issue has been covered in EA. Factory performed EA and EA was accepted by ACCORD on 12/11/2017. According to EA recommendation, factory is required to remove the stair. Stair deteriorated due to corrosion and susceptible to falling hazard. Factory still using the stair. Factory is required to stop using the stair and demolish immediately.</p> <p>On 09/09/2018: Factory performed EA and EA was accepted by ACCORD on 12/11/2017. According to accepted EA factory is required to demolish the external fire stair, but factory still using the stair.</p> <p>On 24/11/2018: As per approved DEA, factory is required to demolish the external fire stair. Till the inspection day, factory did not demolish the stair.</p> <p>On 12/05/2019: Factory did not demolish the stair till the date of inspection day.</p> <p>On 15/10/2019: Factory demolished the stair.</p>	Corrected

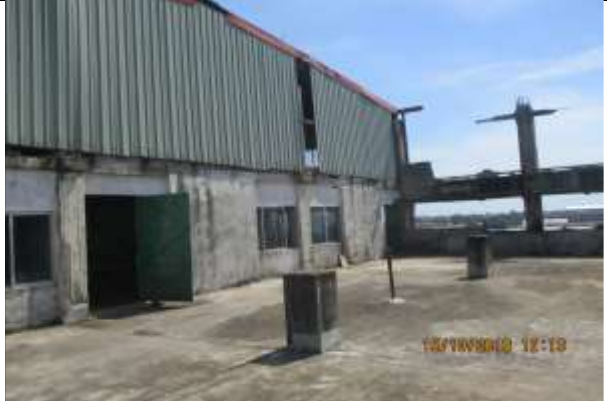
17	Condition of roof slab following demolition works- tidy up, water proofing and drainage to be provided.	Priority-2-Construction rubble/demolition material to be removed from building roof.	Priority-2 (Within 6 weeks)	Corrected	25-Sep-2015	<p>On 16/03/2016: Previous Timeline: 25/09/2015 During inspection no material was found on roof.</p> <p>On 12/02/2017: Corrected in previous follow up.</p> <p>On 13/8/2017: Corrected in previous follow up.</p> <p>On 17/10/2017: Corrected in previous follow up.</p> <p>On 21/03/2018: This issue was corrected from previous inspection.</p> <p>On 09/09/2018: This issue has been corrected from previous inspection.</p> <p>On 24/11/2018: Corrected from previous follow up. During inspection, no construction material was found on roof.</p> <p>On 12/05/2019: The issue is corrected as per previous inspection.</p> <p>On 15/10/2019: Corrected in previous follow up inspection.</p>	Corrected

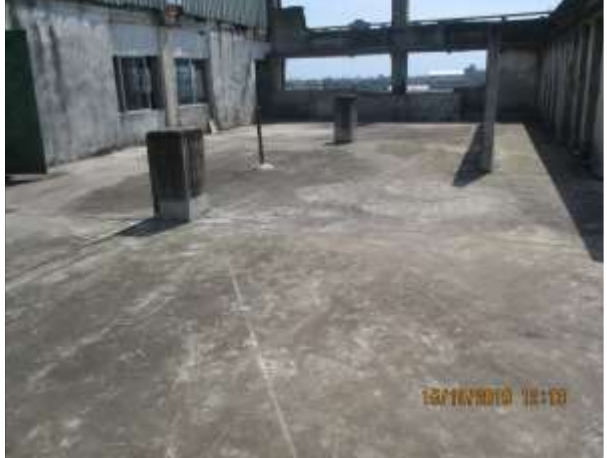
18	Condition of roof slab following demolition works- tidy up, water proofing and drainage to be provided.	Priority-3-Roof drainage system to be installed and concrete slab to be waterproofed at locations where the slab has been damaged.	Priority-3 (Within 6 months)	Corrected	25-Sep-2015	<p>On 16/03/2016: Previous Timeline: 25/09/2015 Water proofing observed on roof. Factory management provided a cc coating on roof & drainage system also repaired.</p> <p>On 12/02/2017: Corrected in previous follow up.</p> <p>On 13/8/2017: Corrected in previous follow up.</p> <p>On 17/10/2017: Corrected in previous follow up.</p> <p>On 21/03/2018: This issue was corrected from previous inspection.</p> <p>On 09/09/2018: This issue has been corrected from previous inspection. Factory authority provided the water proofing and drainage system.</p> <p>On 24/11/2018: Corrected from previous follow up. Factory authority provided water proofing membrane on roof.</p> <p>On 12/05/2019: The issue is corrected as per previous inspection.</p> <p>On 15/10/2019: Corrected in previous follow up inspection. Factory authority provided the water proofing and drainage system.</p>	Corrected

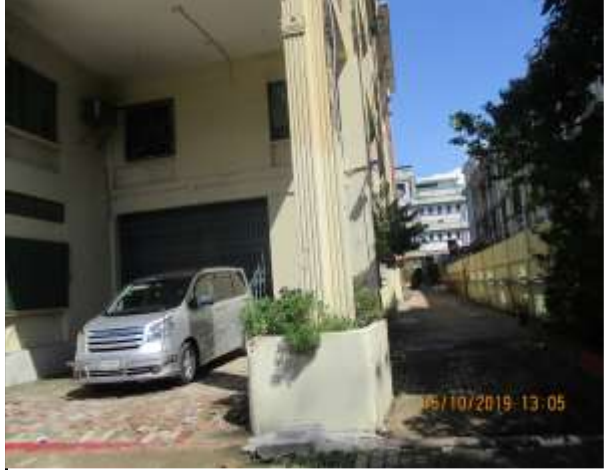
Item No	Accord Observation	Accord Recommendation	Accord Timeline	Final Action Plan	Final Timeline(DD/MM/YYYY)	Comments after Physical Inspection	Progress Status	Pictorial Evidence
19	New findings: No vehicle/impact protection for double storey column on west(front) entrance.	Engineer to include it in EA if the double storey column is designed for impact loading. Moreover, suitable column barriers to be installed around.		Corrected	30-Sep-2015	<p>On 16/03/2016: Previous Timeline: 30/09/2015 Notches on exterior column were repaired. Factory engineer provided a rcc block around that column.</p> <p>On 12/02/2017: Corrected in previous follow up.</p> <p>On 13/8/2017: Corrected in previous follow up.</p> <p>On 17/10/2017: Corrected in previous follow up.</p> <p>On 21/03/2018: This issue was corrected from previous inspection.</p> <p>On 09/09/2018: This issue has been corrected from previous inspection. Factory provided barriers around the double story column.</p> <p>On 24/11/2018: Corrected from previous follow up. Protection provided to columns against vehicle impact.</p> <p>On 12/05/2019: The issue is corrected as per previous inspection.</p> <p>On 15/10/2019: Corrected in previous follow up inspection. Factory provided barriers around the column.</p>	Corrected
